# ROAD & BRIDGE PRECONSTRUCTION ENGINEERING

# Review of Servicewide Practices & Chief's Action Plan

EM-7720-3

**JULY 1977**

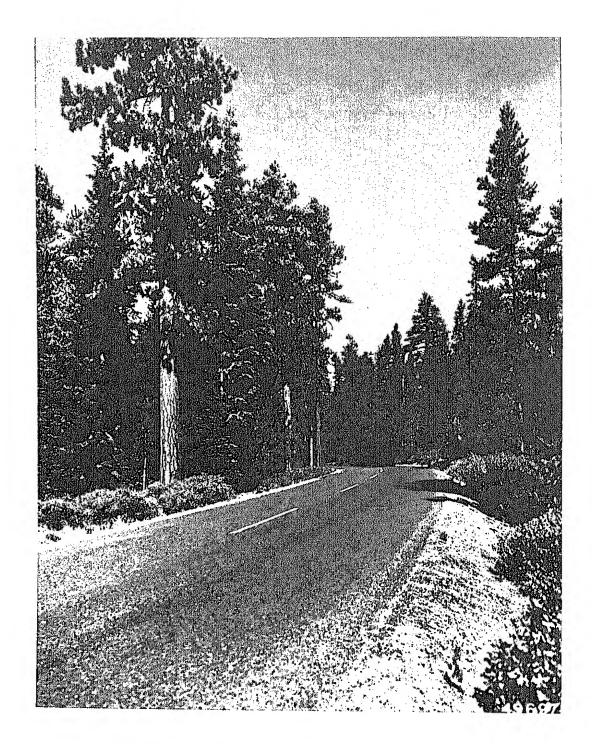
Figure 1. Arterial Scenic Recreation Road, R-6
The Cascade Lakes Highway at a point where it passes through a stand of old growth ponderosa pine on the Deschutes National Forest in Oregon. This section has good curvilinear alignment over flat terrain. Another section, however, has a very long, esthetically displeasing tangent.

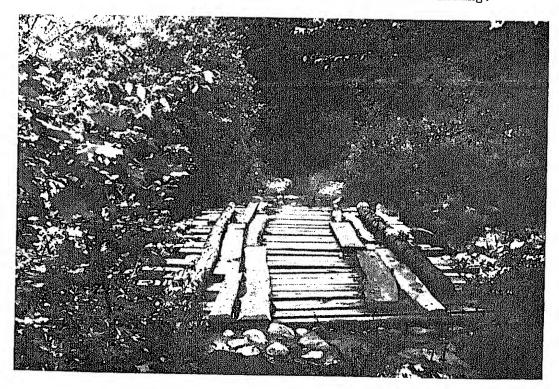
Figure 4. West Branch of Deerfield River Bridge, R-9 An old, existing, unsafe, single-lane bridge. This has been replaced with a new bridge downstream from this location (see figure 8) on the Green Mountain National Forest.

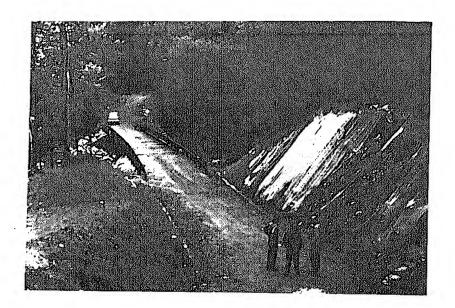
Figure 8. West Branch of Deerfield River Bridge, R-9. The cut slope does not meet the Forest's Plan requirements for maximum cut height. However, it probably is the best design for balancing grade, fill, and cut problems. This bridge replaces the one shown in figure 4.

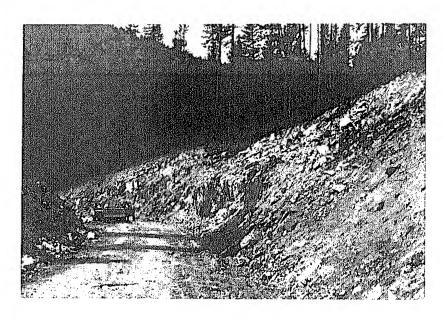
Figure 9. Marias Timber Sale Road, R-1.
No geotechnical investigation was made during preconstruction. Common excavation was originally assumed for the design. Clearing was completed as required by the original design. When rock was encountered, the cut slope was steepened. This resulted in excess scarring and expensive excavation, giving an appearance of "overbuilding."

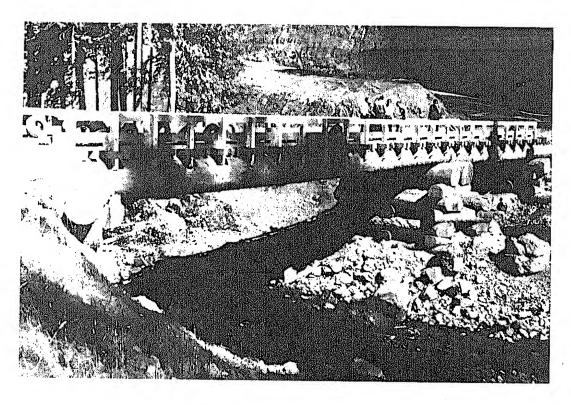
Figure 10. Little Nisqually Bridge, R-6. Untreated "temporary" log stringer bridge, Gifford Pinchot National Forest.

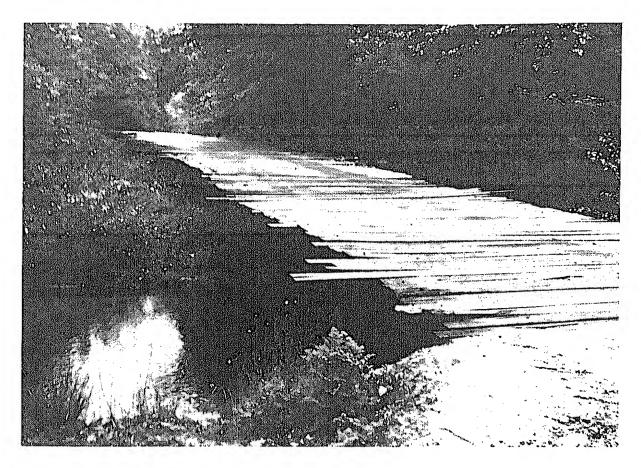
Figure 12. Unsafe, single-lane bridge. An example of unsafe bridges which are unsigned and remain open to the public.
